# Wall Stabilization Walmart

### ❖ Failing MSE wall

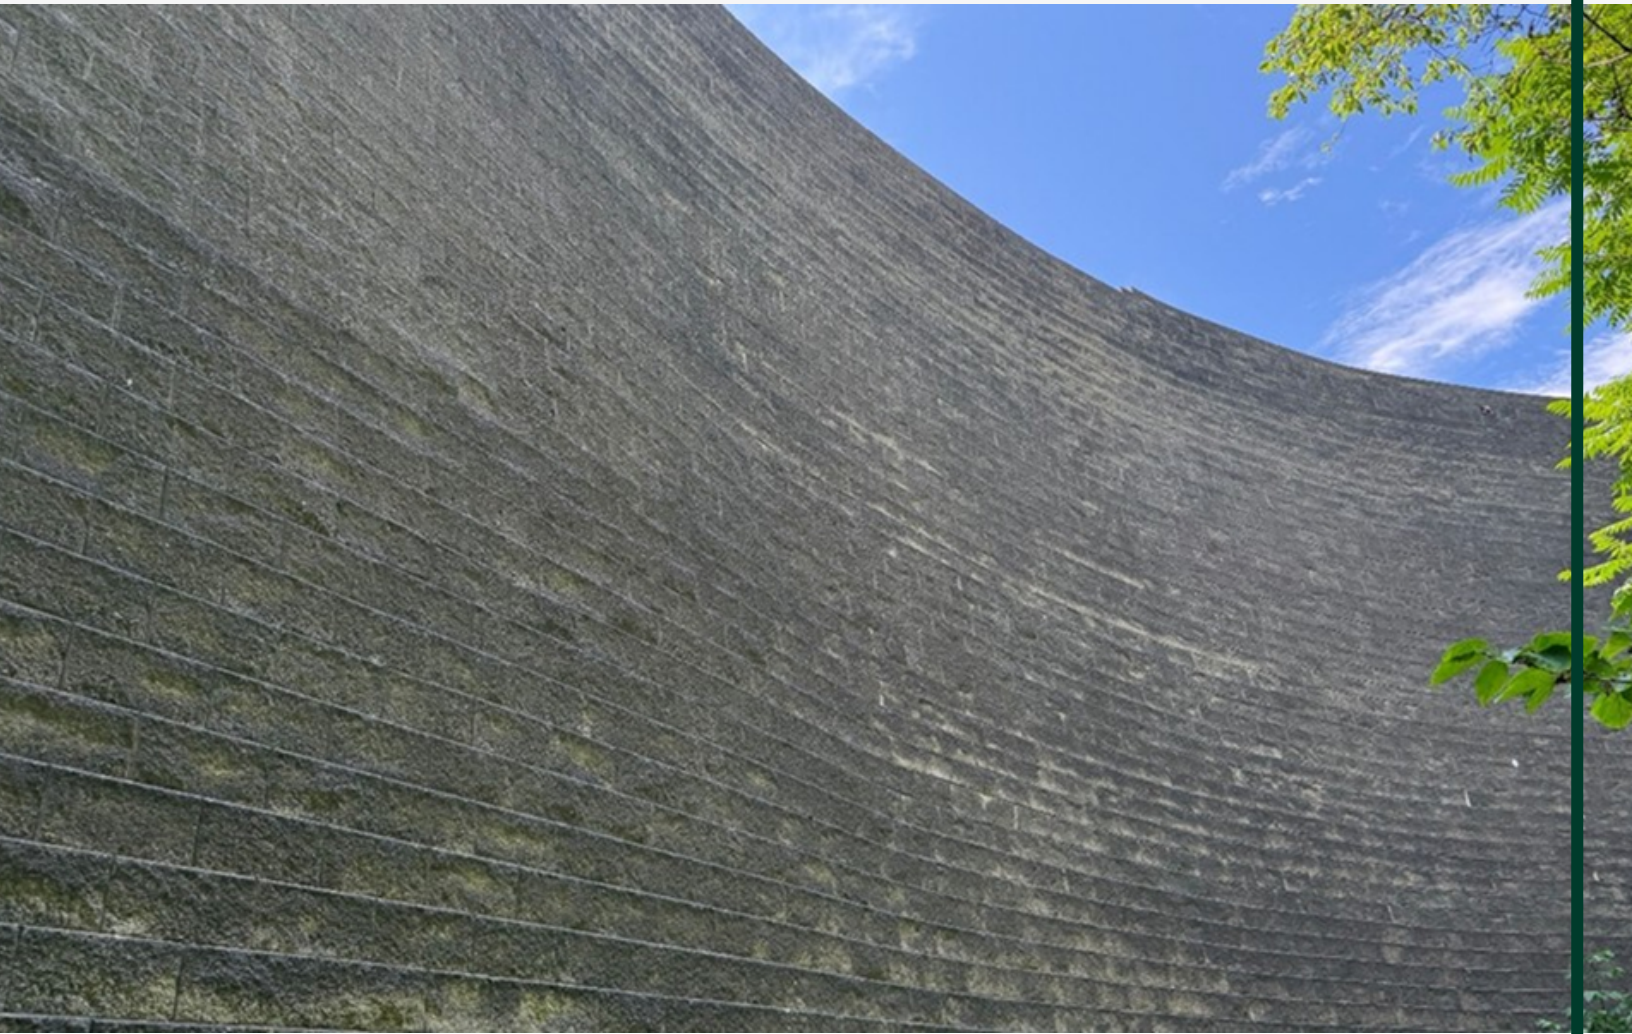
25 years ago, Walmart's distribution center used segmental block MSE to retain a 50-foot tall 25,000 SF soil embankment for the construction of a large parking lot. Over time, freeze thaw combined with a failure of the drainage layer caused distress to the wall, creating the risk of failure or collapse. There were significant access challenges for this project as well as harsh weather conditions due to its location in the Adirondack Mountains and contract delays that pushed the work deeper into the cold months.

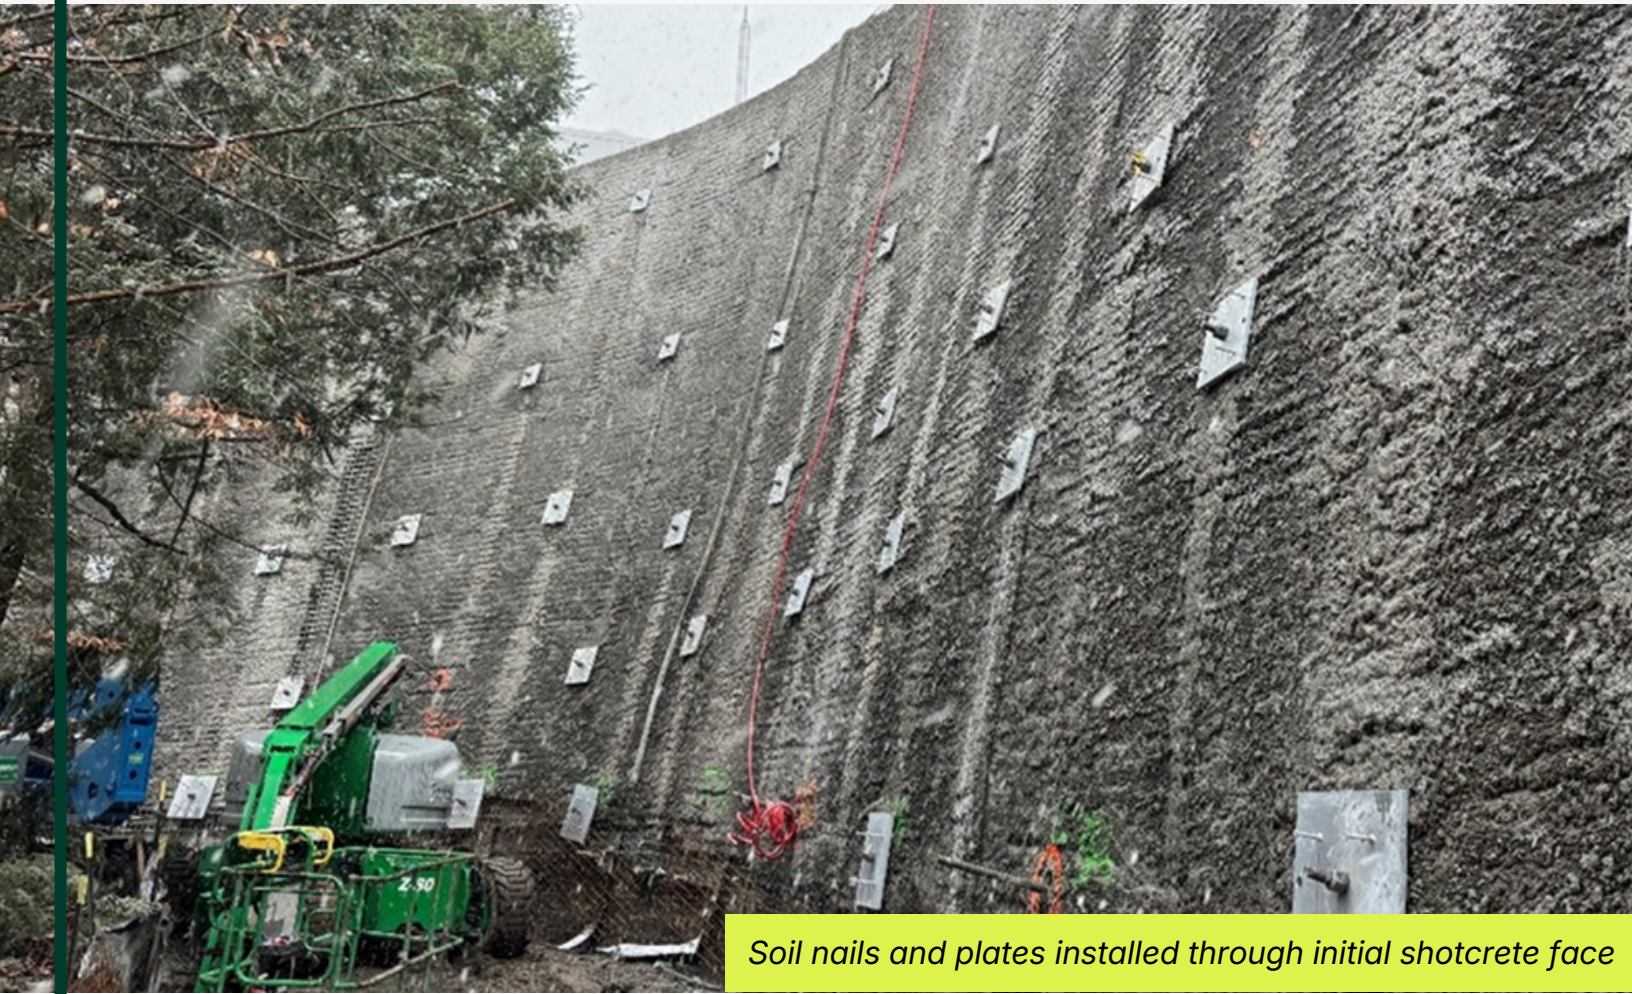
*Soil nails and plates installed through initial shotcrete face*

## 2-layer shotcrete

We installed a two-layer reinforced shotcrete wall with T40/20 hollow bars in an 8' x 10' grid. We tension tested the nails to 92,000 lbs and drilled them through the initial shotcrete layer before installing a final layer over top of the nails.

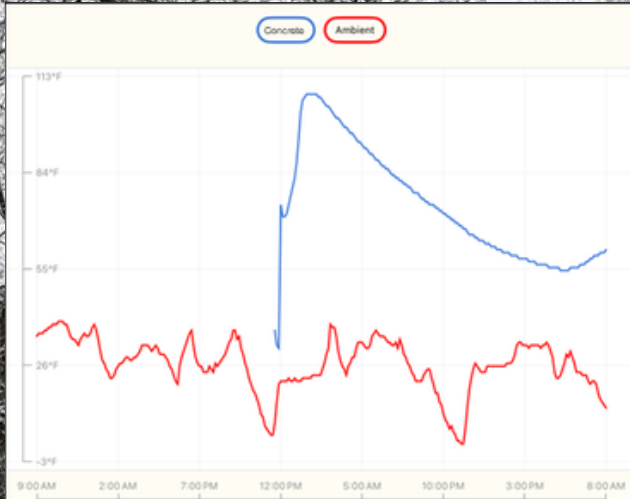
*By proving concrete temperature behavior, we showed that the shotcrete complied with the provisions of ACI 306-16: cold weather concreting.*

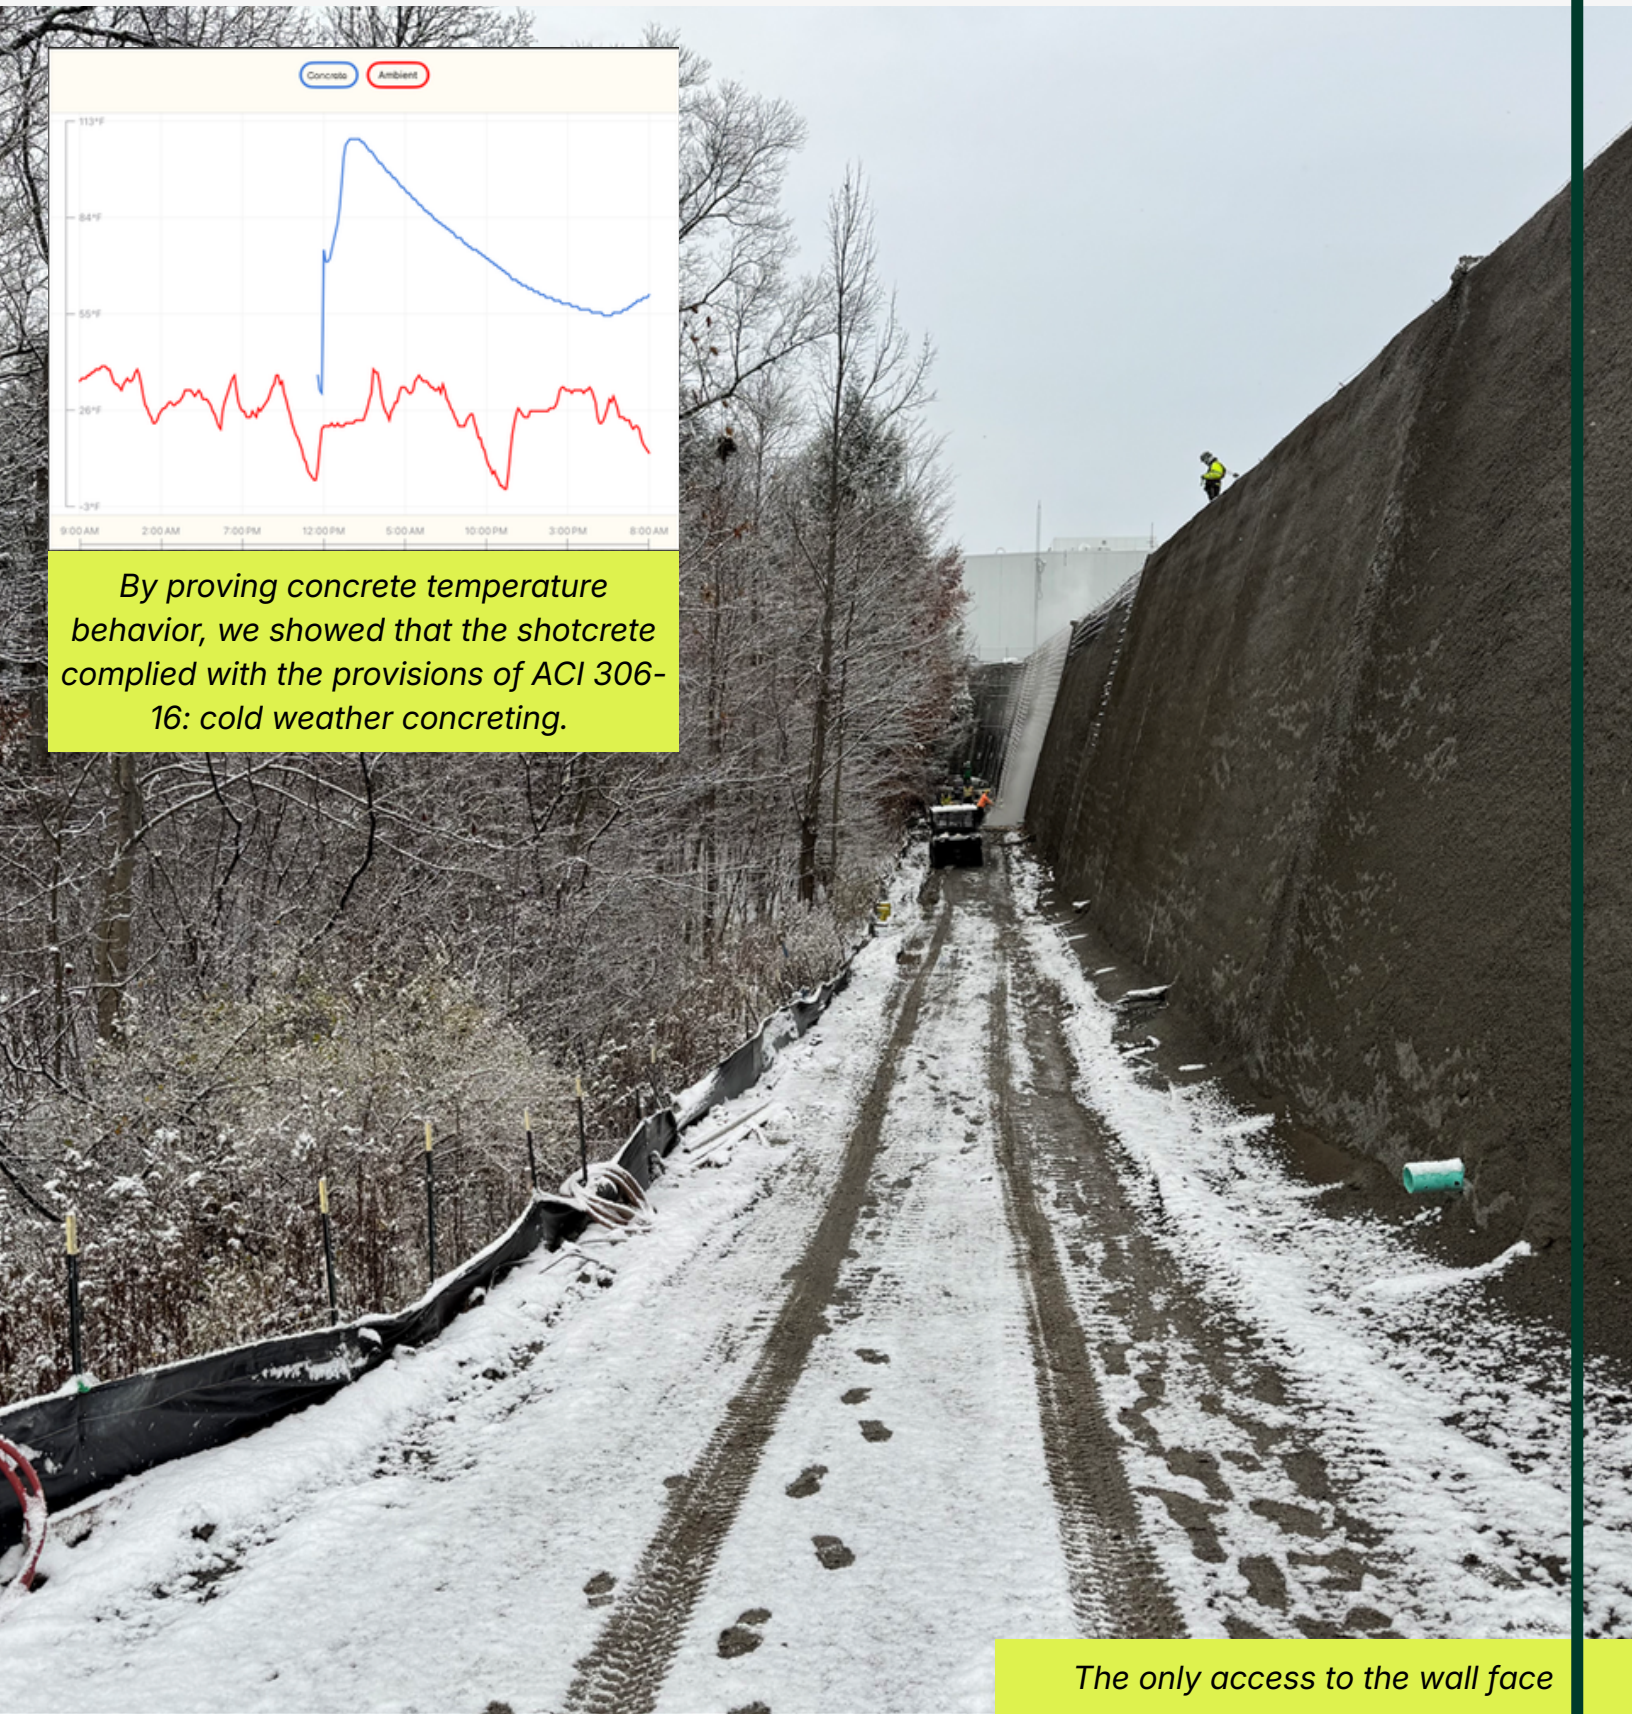
*The only access to the wall face*
