# Restoration Culvert Lining

## **Forcine Concrete**

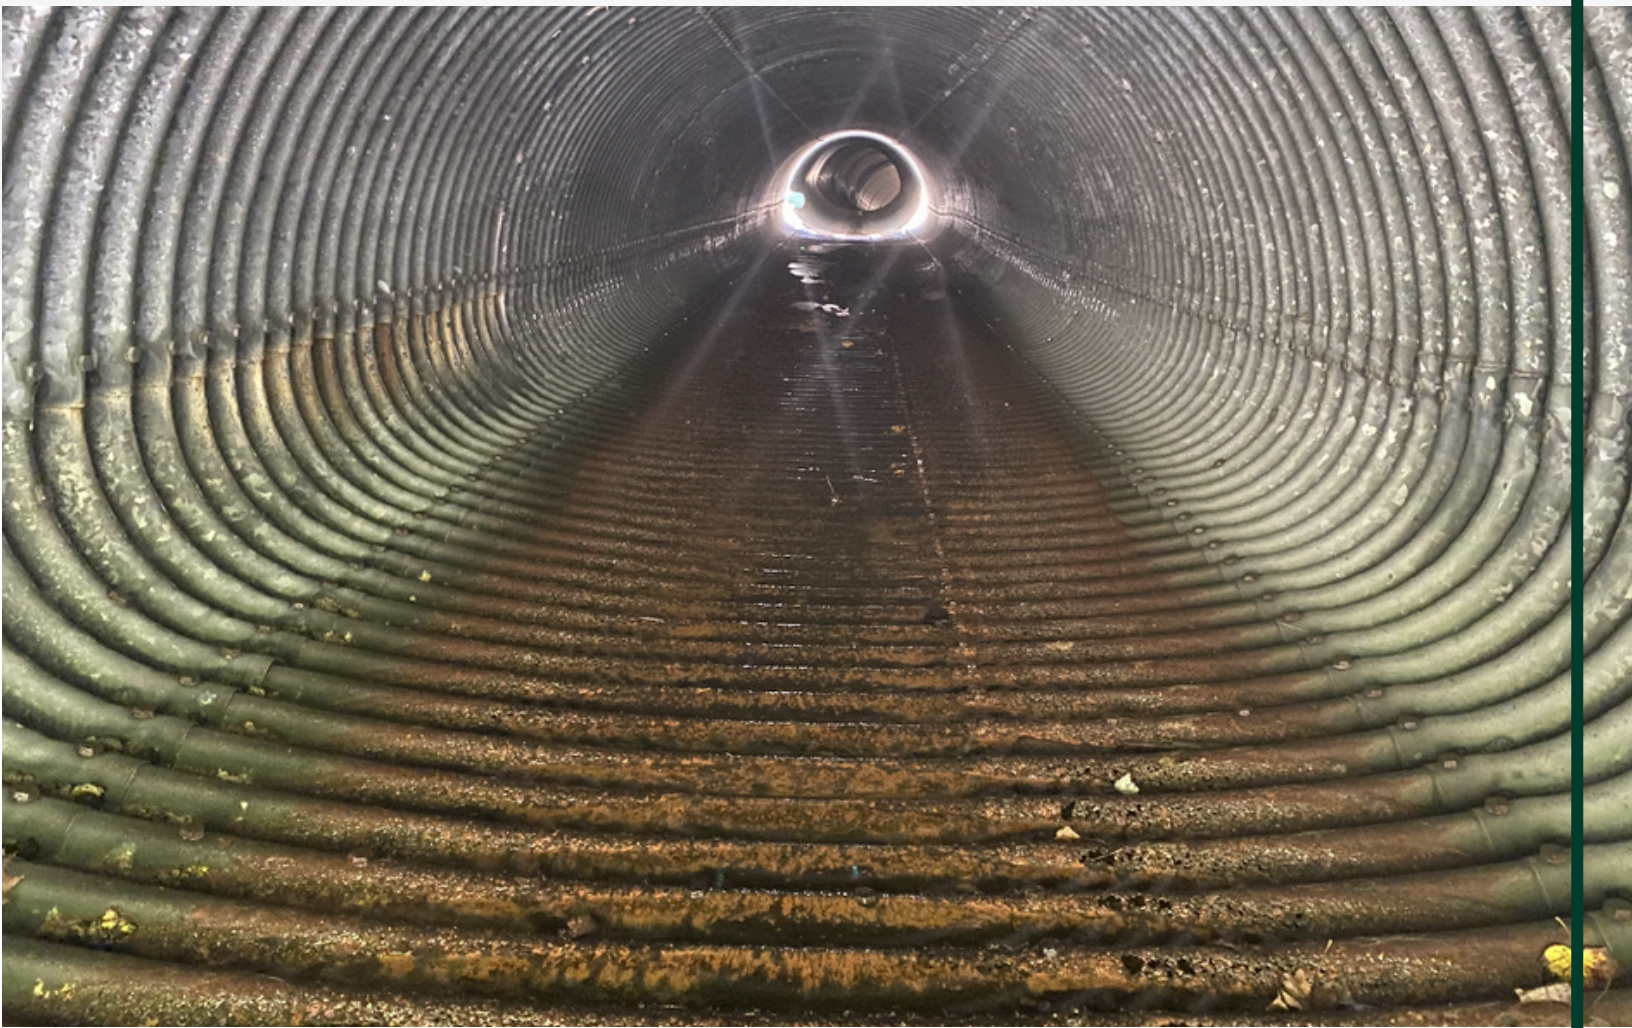
# Problem

## Water bypassing

This deteriorating corrugated metal pipe (CMP) was located under a heavily travelled road. Failure of the metal allowed water to bypass the CMP, removing the soil support underneath and requiring rehabilitation.

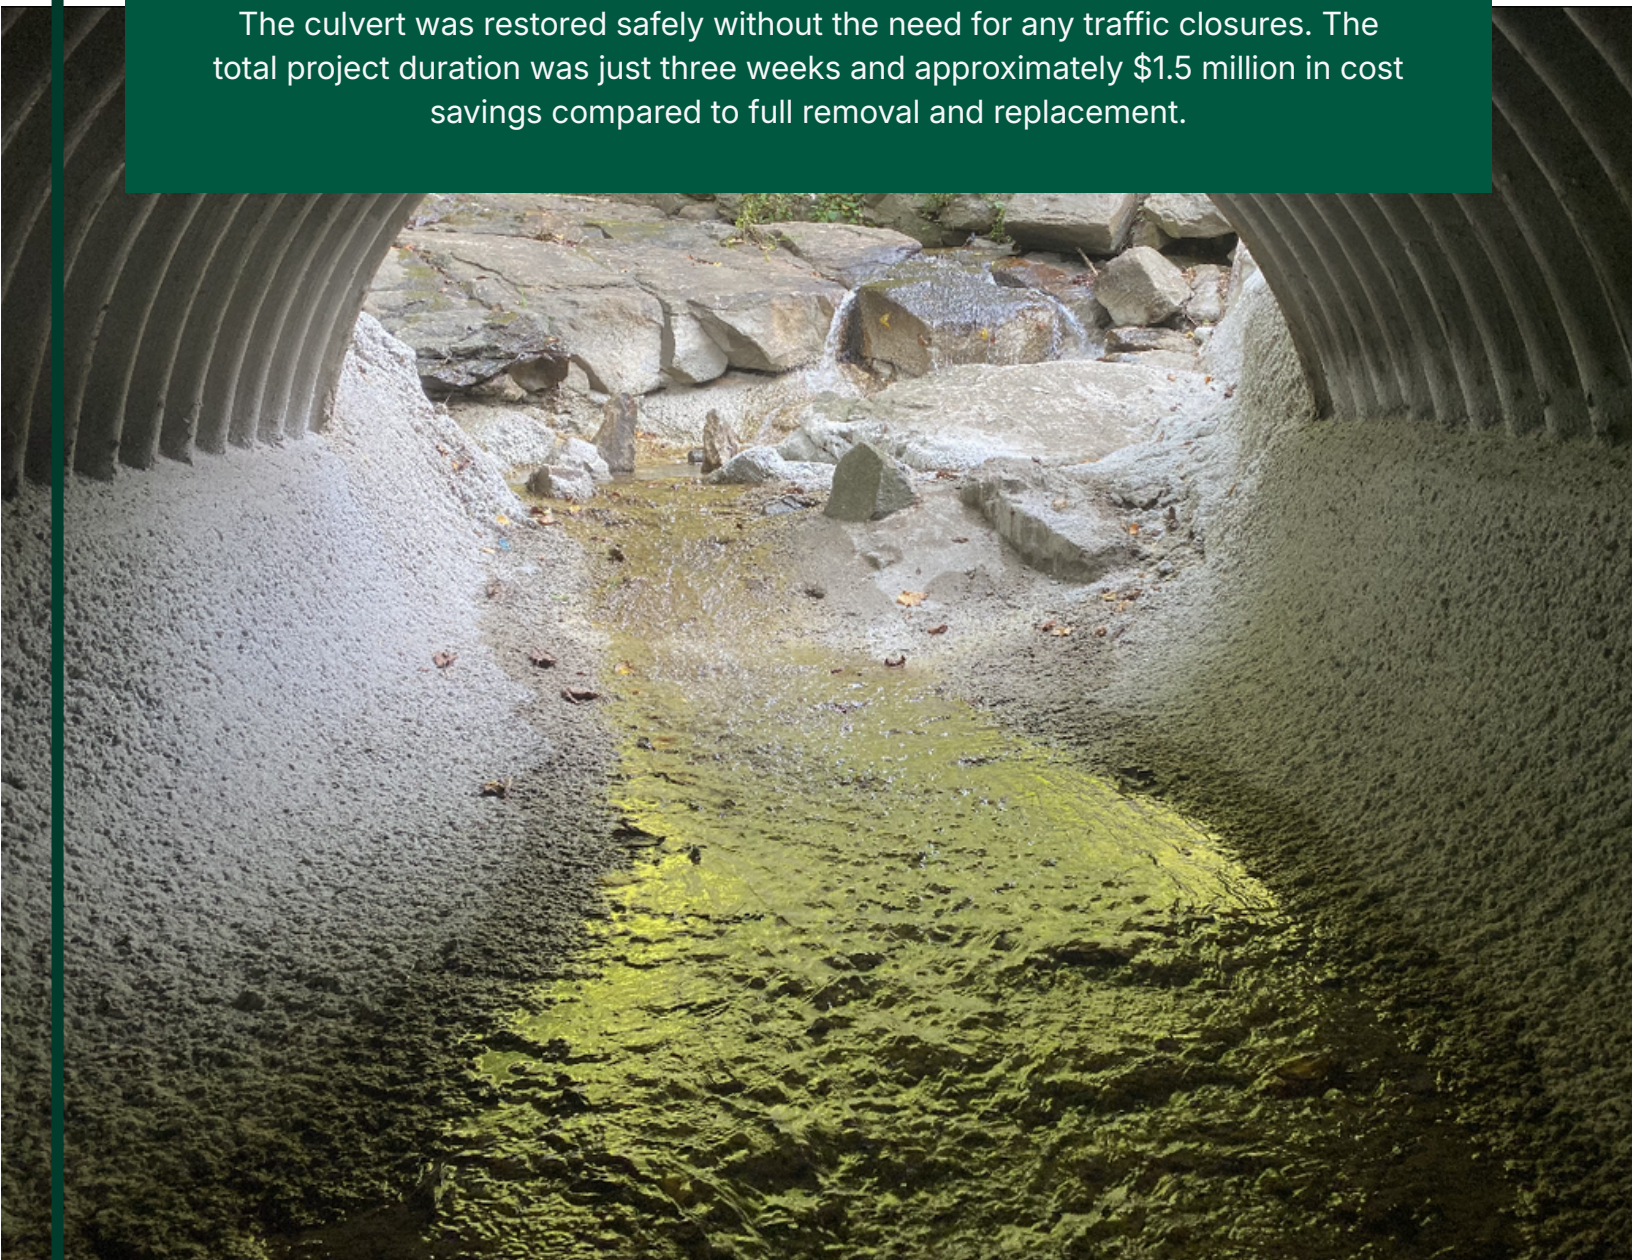
# Results

## Restored culvert

**4 MONTHS TIME SAVED, SIGNIFICANT COST SAVINGS**

The culvert was restored safely without the need for any traffic closures. The total project duration was just three weeks and approximately \$1.5 million in cost savings compared to full removal and replacement.
